Maryland Historical Trust

MHT Number CE-1495

Maryland Historical Trust SHA Bridge No. 7009 Name: MD 7 over Northeast Creek (Northeast Creek Bridge) Location: Street/Road Name and Number: MD 7 (Old Philadelphia Road) City/Town: Northeast Vicinity X County: Cecil Ownership: X State County Municipal Other This bridge projects over: __Road__Railway X_Water Land Is the bridge located within a designated district: yes X no _NR listed district_NR determined eligible district _locally designated_other Name of District **Bridge Type:** _Timber Bridge _Beam Bridge_Truss-Covered_Trestle _Timber-and-Concrete _Stone Arch Metal Truss _Movable Bridge _Swing _Bascule Single Leaf_Bascule Multiple Leaf _Vertical Lift_Retractile_Pontoon _Metal Girder _Rolled Girder _Rolled Girder Concrete Encased _Plate Girder _Plate Girder Concrete Encased _Metal Suspension _Metal Arch _Metal Cantilever X_Concrete X Concrete Arch Concrete Slab Concrete Beam _Rigid Frame _Other Type Name_

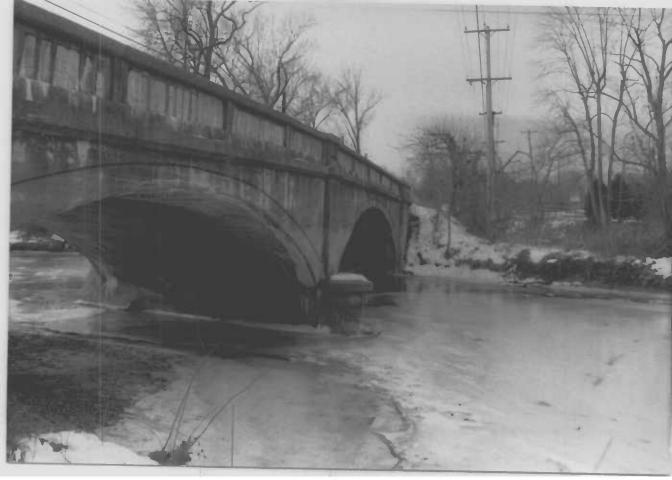
CE-1495 CECIL COUNTY MD MATT HURLEY FEB 14 1995 MARYLAND SHO SHA BRIDGE NO 7009 UPSTREAM SIDE OF BRIDGE 7 OF 8

Bridge 7009 is a double-span filled spandrel concrete arch bridge. The length of the bridge is 153 feet with each span measuring 59 feet. The arches have a rise of 8 feet 5 inches from springline to crown. There is a clear roadway width of 24 feet, with an overall width of 27 feet 4 inches. The bridge originally had open parapets, but these were filled at a later date. The bridge has 2 concrete abutments, and a concrete pier. There a 4 flared concrete wingwalls. Two bronze plaques are attached to the bridge, indicating that it was designed by the Luten Bridge Company and built by the State Roads Commission in 1922. According to a 1996 inspection report, the bridge is in satisfactory condition, with a sufficiency rating of 79.9.
